Drilling Operations of the First Iceland Deep Drilling Well (IDDP)

Landsvirkjun (The National Power Company in Iceland) drilled the first IDDP science well of three proposed by the research project, in NE-Iceland at Krafla. The IDDP consortium is composed of Landsvirkjun, HS Orka and Orkuveita Reykjavíkur, Alcoa Inc. Canada, StatoilHydro ASA, Norway, ICDP, US NSF, Orkustofnun. Preparation for the drilling initiated in the year 2000 and continued until the drilling activity started with a pre drilling in the mid year 2008 and a drilling to 800 m started later in the same year. Drilling to 4,5 km continued in March 2009 in the search for a supercritical fluid. However, after almost three months of drilling problems, getting stuck, having twist offs, and having to sidetrack two times, the source of these problems became clear at 2104 m depth when the drillbit had obviously drilled into a magma pocket of some size. Quenched volcanic glass was returned to the surface, estimated to have been about 1050°C before cooling.

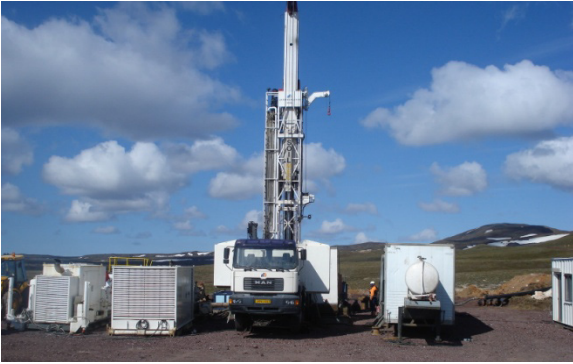
Figure 3. The rig Saga.

Pre drilling of IDDP-1 began in June 2008, with a Drillemec G55 truck mounted rig, “Saga” (Figure 3. The rig Saga.). The well was drilled with a $\phi 26$ ” roller cone bit and a $\phi 36$ ” under-reamer (Figure 6. The 36” under-reamer.) and was drilled with mud down to 87 m depth in nine days. At that depth the formation was stable for the casing shoe and a decision to run the casing was reached. The casing was cemented with 29,5 m³ of high temperature cement slurry.

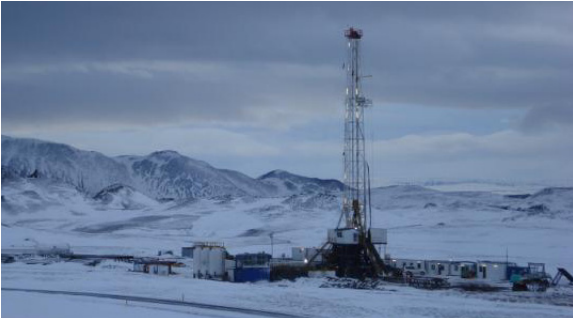
Figure 4. The rig Jotunn.

Drilling for the Intermediate casing I began 1st of November 2008 with mobilization, maintenance and adjustments to fit the large diameter drilling assembly of the rig “Jötunn” (Figure 4. The rig Jotunn.). The drill string was inspected according to DS-1, Service Category 4 before RIH for the first time. Before each RIH after that the string was ultrasonic inspected. The rig, Gardner Denver 700 E, began drilling the 18th of November through cement at the bottom. The first section was drilled with $\phi 26 \frac{1}{2}$ ” Hughes Christensen Roller cone rock bit and water based mud. No mud motor was used in this section.

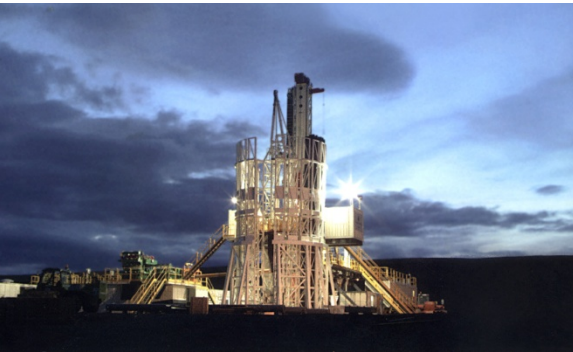
Figure 5. The rig Tyr.

The rig Týr Drillemec HH-300 (Figure 5. The rig Tyr.) was mobilized to the wellsite in middle of March 2009 and RIH commenced 24th of March. The drill string was inspected according to DS-1, Service Category 4 before RIH for the first time. Before each RIH after that the string was ultrasonic inspected. The BHA consisted of a $\phi 16 \frac{1}{2}$ ” roller cone bit, $\phi 9 \frac{1}{2}$ ” mud motor and a sleeve, two stabilizers, Anderdrift tool, $\phi 9 \frac{1}{2}$ ” and $\phi 8$ ” drill collars, shock sub, jar and heavy wall drill pipes. The cement was drilled out to 788 m and drilled into formation to 803 m before replacing the water with drill-mud for circulation. A mud specialist and a mud engineer from AVA S.p.a. Italy were hired for mixing and maintain the properties of the circulation fluid. A sudden pressure drop on the stand pipe was observed the 29th of March at 1194 m depth and simultaneously the torque dropped dramatically. A float sub had twisted apart in the BHA and a fish was in the hole. The string was pulled out and what remained in hole was the bit, the mud motor, a stabilizer and the other part of the twisted float sub. Fishing tools were mobilized to the site but due to bad weather conditions and blocked roads the mobilization was delayed for 20 hours. Just before midnight on the 30th of March an over-shot was RIH and 23 hours later the fish was on surface. The mud motor was blocked and had to be replaced.

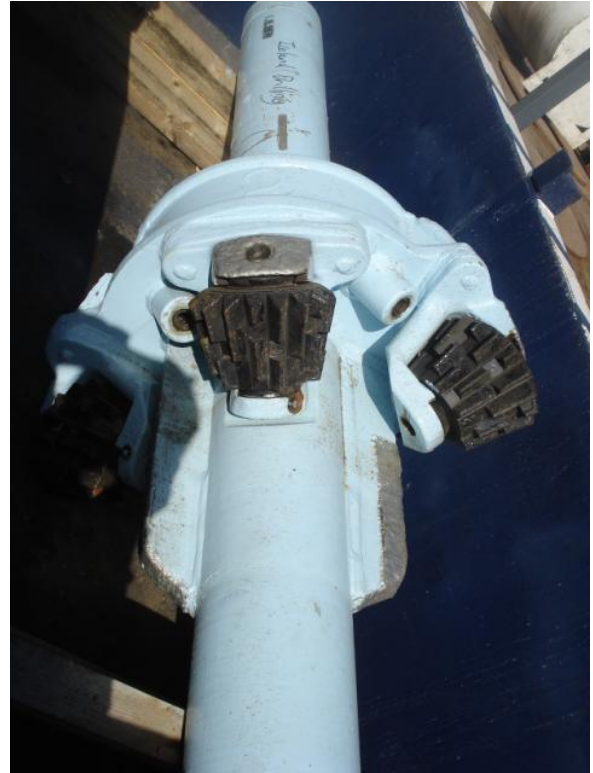
Figure 6. The 36" under-reamer.

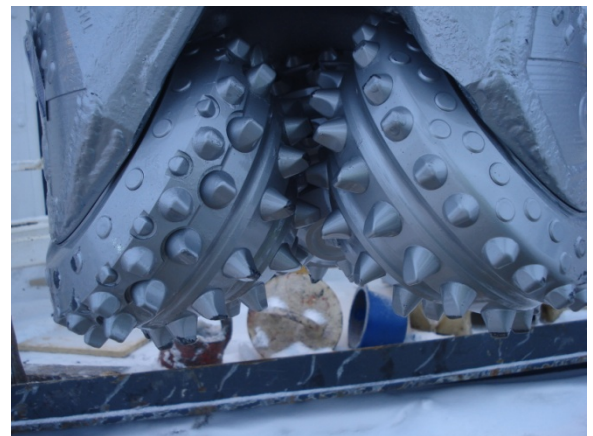
Figure 7. New roller cone bit.

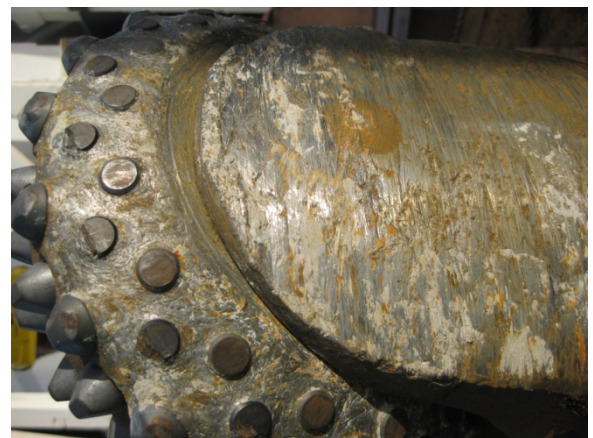
Figure 8. Worn roller cone bit.

In the morning 2nd of April drilling commenced again at 1194 m. ROP varied from 3-5 m/hr and small losses were detected at 1362 m and healed with LCM pills. ROP decreased and testing showed that either the bit or the mud motor was failing and at 1400 m a decision was made to POOH. The bit was 2/16” under-gauged but the stabilizers were in gauge. The mud motor was not working properly and had to be replaced. At 1432 m depth losses of 20 l/s were detected. LCM pills were pumped down hole without progress and at 1447 m it was decided to POOH and cement off the losses to minimize the mud losses and secondly to prevent interflow between loss zones during the casing procedure. The bit was in surprisingly bad condition after only 47 m drilling. Almost all carbides were broken off on the outer most rows of the cones (Figure 7. New roller cone bit. and Figure 8. Worn roller cone bit.). Temperature log was performed to locate the loss zones. At that time the well, however, appeared to be tight and no losses were detected probably due to previous LCM jobs and the cementing was abandoned. The 7th of April a Junk Basket was RIH trying to retrieve the missing carbides.

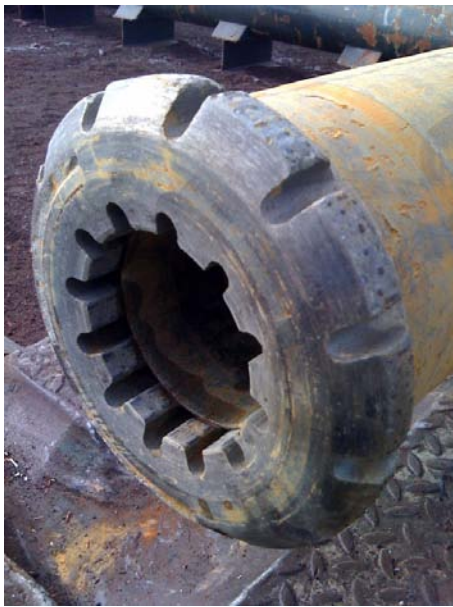
Figure 10. The Core bit after the coring attempt.

RIH with a drilling assembly commenced the 31st of May and decision made to drill down to 2040 m depth and then drill a 9 m spot core in a known fracture zone, observed in previous track. A coring specialist from ROK-MAX (UK) Ltd. arrived to supervise the coring job. After having circulated the well clean on the 1st of June the string was POOH and the coring equipment was prepared. The bit was worn and marred on the skirts and the hard facing on the stabilizers were worn and the blades were also marred. On the 2nd of June the coring job started at 2040 m. The drilling progressed slowly and after 3½ hours only 2 m had been drilled. It was decided to POOH and check the equipment. In the morning of the 3rd of June the POOH was completed. The core bit was completely worn down (Figure 9. New Core bit. and Figure 10. The Core bit after the coring attempt.) and some inserts of the core barrel stabilizers were broken off and along the barrel the surface was marred by grooves. No core was in the barrel, while the core catcher had been pressed approx. 70 cm up. Flaky chips of cement were found inside the core barrel probably from the last plug cementing. The flakes probably got the core catcher stuck which had unscrewed inside the barrel. Due to the worn equipment it was suspected that some junk was in the hole.

Based on the suspicion that junk was in the hole it was decided to RIH with an $\phi 12\frac{1}{8}$ " Mill tooth bit and a Junk Basket to retrieve the junk and the rest of the core bit. The plan was to drill down to 2060 m, pull out and cement the losses. On the 5th of June at 2054 m total loss of circulation occurred but the well was drilled to 2060 m before POOH. POOH finished on the 6th of June and the junk in the basket consisted of formation fragments, small metal shavings and diamond fragments from the core bit.

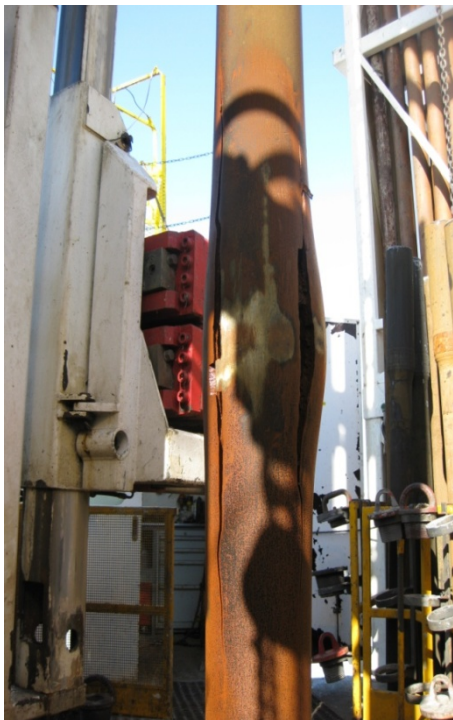
Figure 11. The 8" DC after the explosion.

A sudden pressure drop on the stand pipe was observed the 18th of April at 2074 m and the torque dropped dramatically. A box of ø8" drill collar had twisted apart and a fish of 7 tons was in the hole. An over shot was run in hole and two hours were needed for freeing the fish. A new BHA was run in hole on the 20th of April and drilling commenced again at 2074 m.

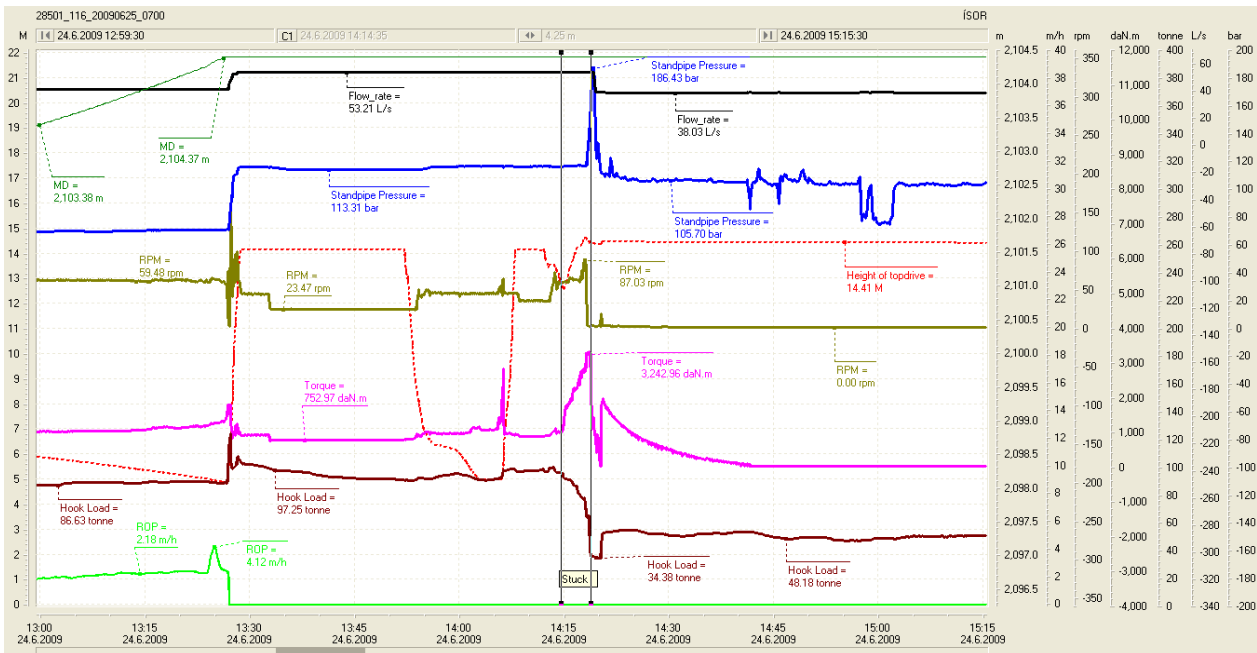
Figure 14. The events from the rig's data logging system when drilled into magma for the third time.

At 2104.4 m the ROP doubled (from 2 m/hr to 4 m/hr), the torque increased and the string was stuck and had to be pulled (125 tons) to free it. A single was pulled out and the well was circulated for 1 ½ hour. The bit was run down to bottom again slowly and the torque increased again at the same depth as before and a single was pulled out again and waited for a few minutes. When running in again (2 m) the top drive and the single on the floor moved upwards and the weight decreased by 45 tons and immediately the string was stuck (Figure 14. The events from the rig's data logging system when drilled into magma for the third time.). The crew managed to maintain the circulation and the returns were pulsating but in a short while it came steady. No smell of H₂S gas was detected but the returns became red-brown in color and after that, cuttings of quenched glass were observed on the shakers. Circulation was maintained for 24 hours without moving the string, but after a while there was no return. After that the string was pulled and it was loose. POOH commenced and the bit was in excellent condition (Figure 12. The bit pulled out after having drilled into magma.). Nothing could be seen on the other parts of the BHA. After it came clear that it had been drilled into magma, further drilling was pointless and impossible.

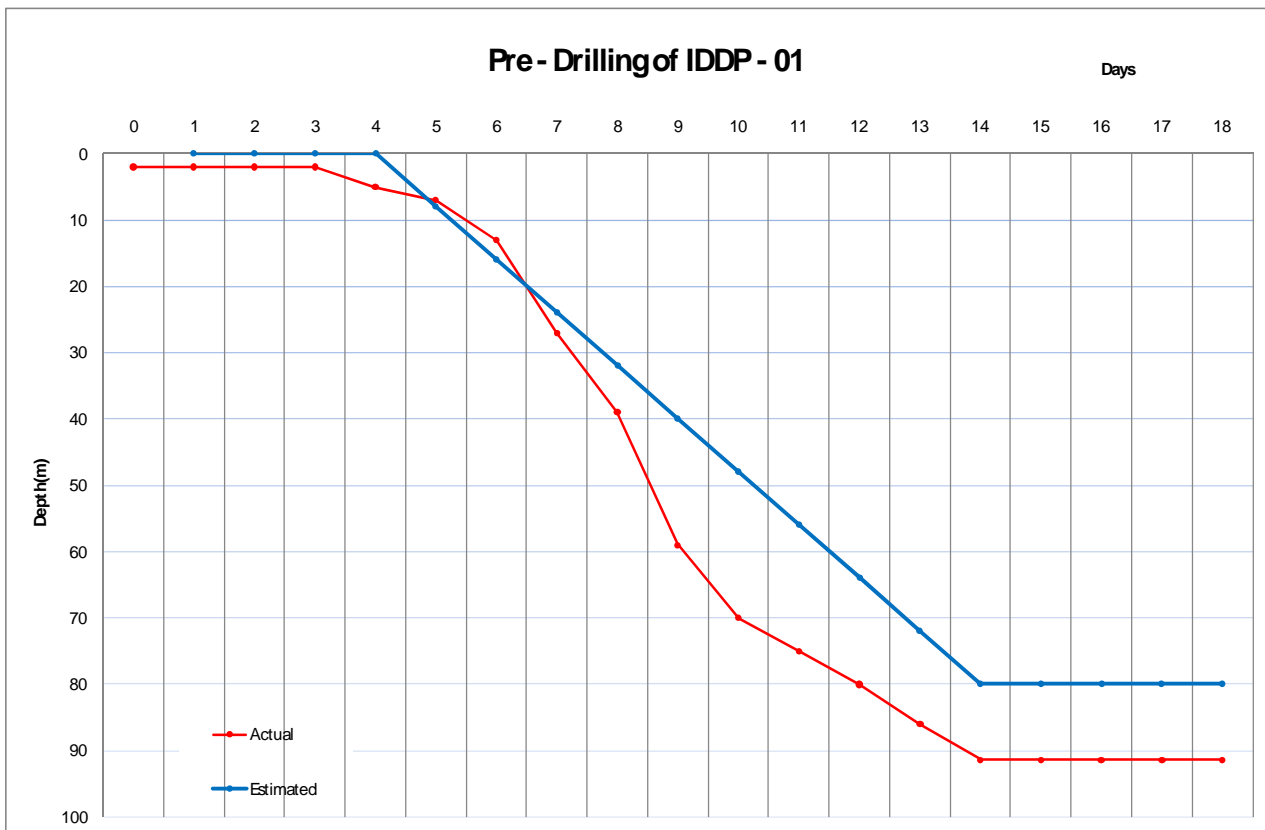
Figure 15. Pre drilling. Drilling program versus actual drilling time.

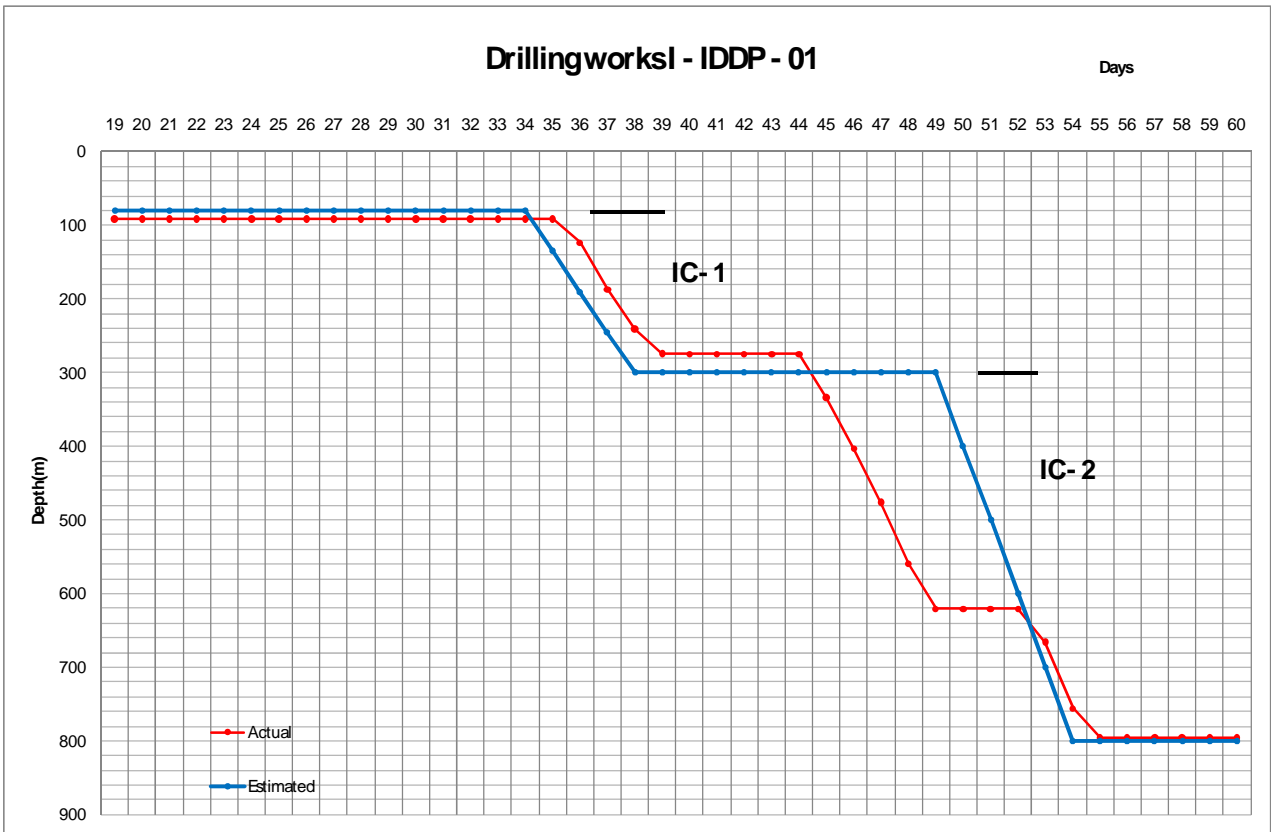
Figure 16. Drilling works I. Drilling program versus actual drilling time.

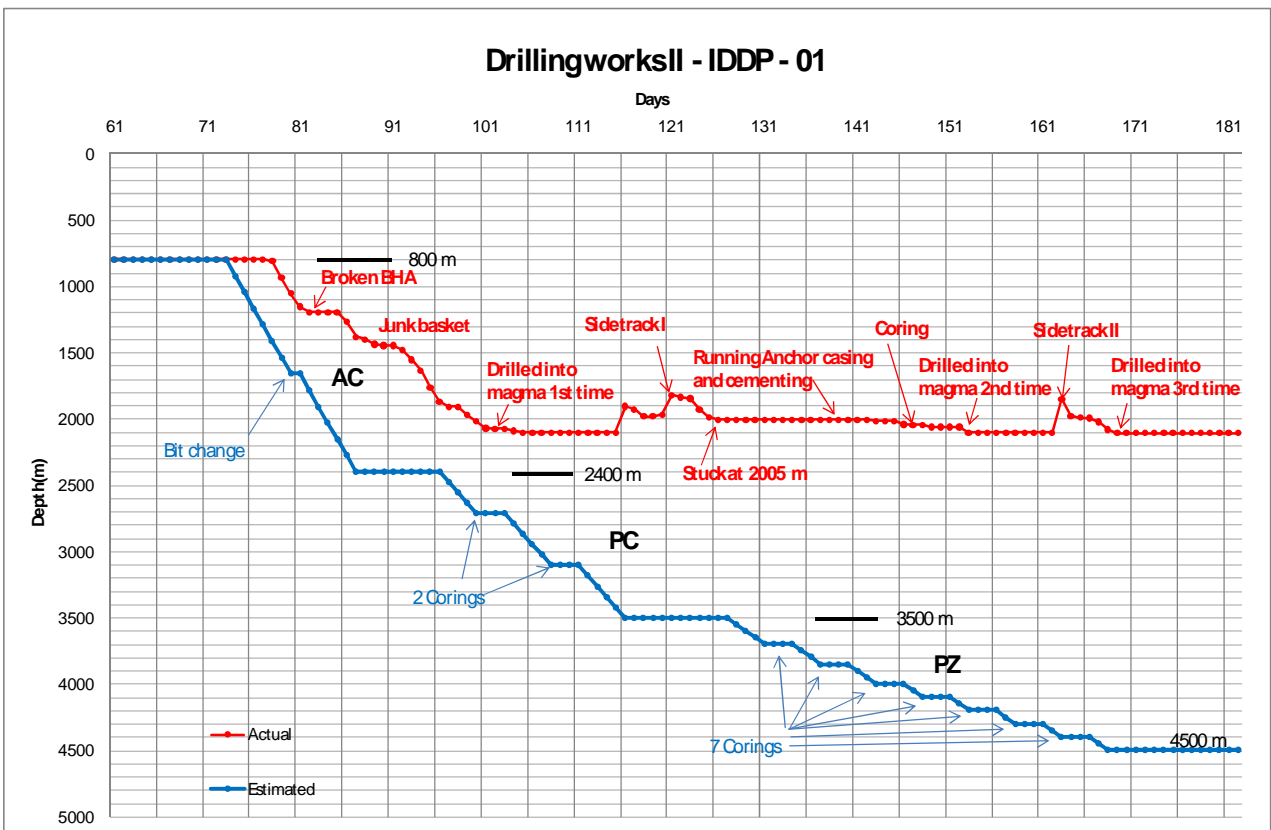
Figure 17. Drilling works II. Drilling program versus actual drilling time.
